# FermZilla Design Revision

**KegLand Distribution PTY LTD**

In late 2019 it was noticed that a small number of Fermzilla tanks had exhibited a small stress mark around the neck of the tanks.

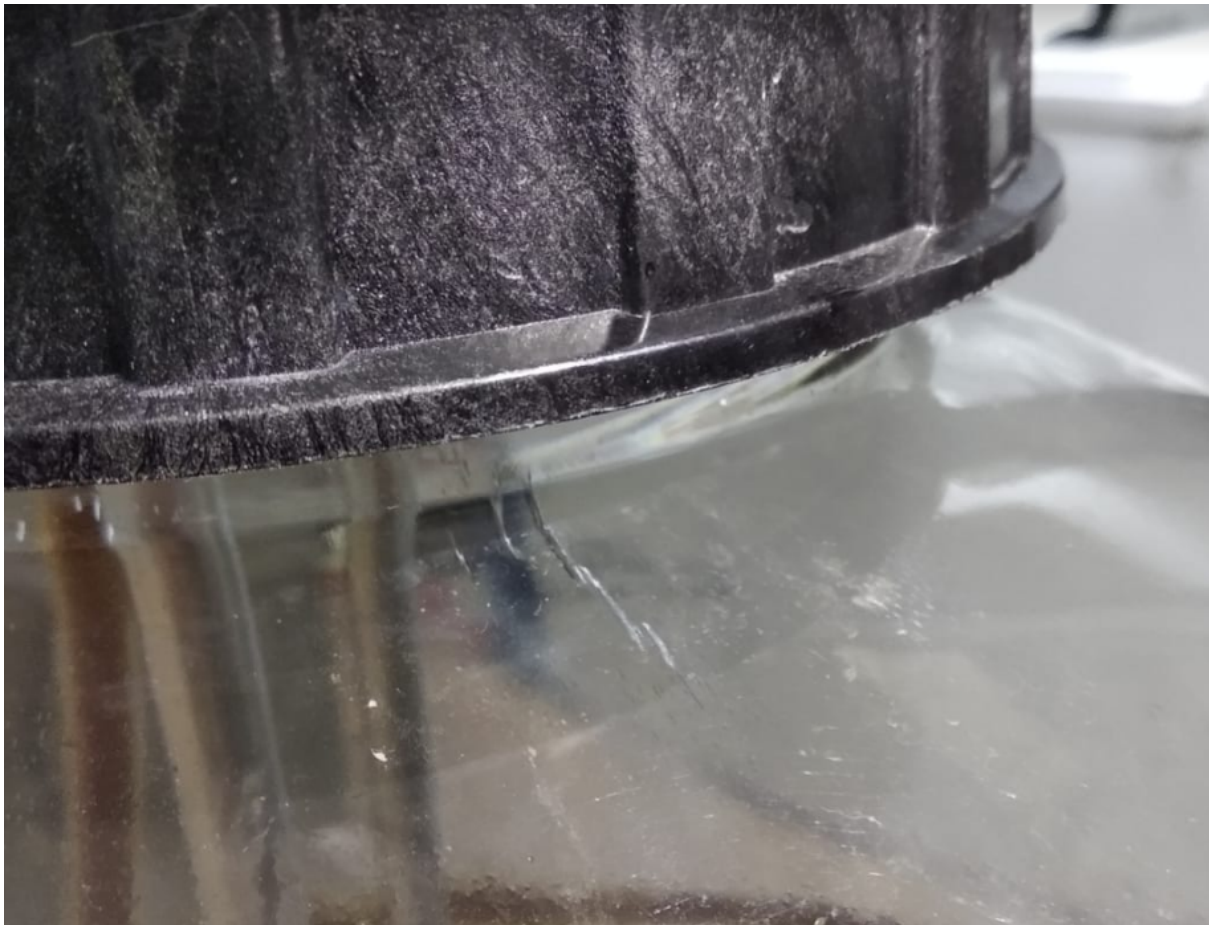
This stress mark was only noticeable in a small number of tanks after they had been used a number of times.

Although it's difficult to track the exact reason for these marks we believe that it could be caused by environmental stress cracking, incompatible chemical cleaners, repeated cycling beyond the rated pressure of the tank or simply excessive stress in the neck area of the tank.

By the start of 2020, 4 known issues like this had been identified and reported to by customers. This concerning issue was addressed with several changes to the:

1. Manufacturing process
2. Testing procedure
3. Blow mould design

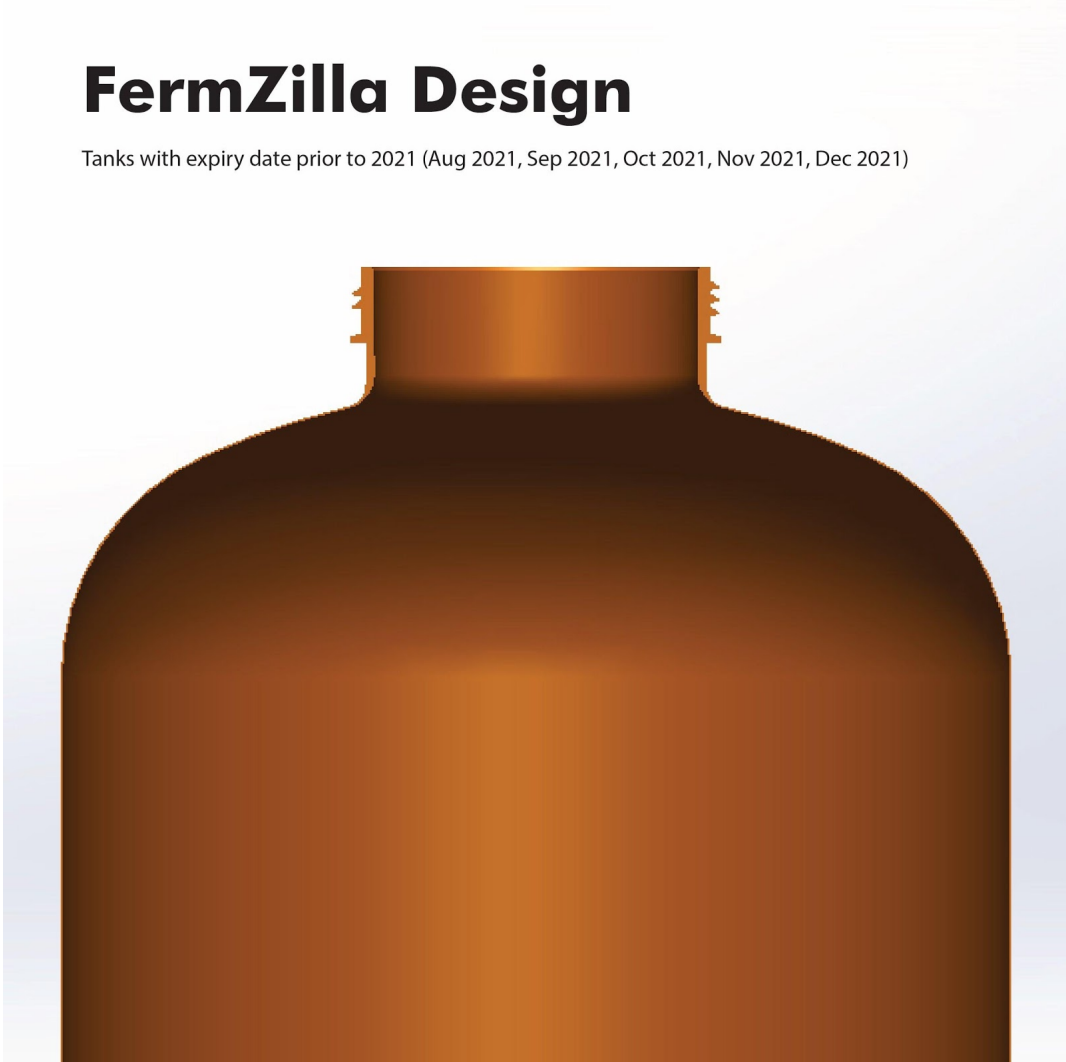
## **FermZilla Design**

When the FermZilla tanks were first designed they were designed specifically to fit into a low head space to make the tanks as compact as possible. To facilitate this objective a torispherical design was adopted for the top of the tank. This shape was only used on the FermZilla 27L, 35L and 55L Conical Tanks. In order to reduce stress on the neck of the FermZilla, the shape of the top of the tank was changed to hemisphere. This had the negative effect of increasing the height of the tanks by approximately 15mm however this design change enabled the tanks to resist higher working pressures and increase overall tank robustness.

The old design with retest date prior to December 2021 are shown below with the shorter torispherical top are shown below.

Tanks with expiry date prior to 2021 (Aug 2021, Sep 2021, Oct 2021, Nov 2021, Dec 2021)

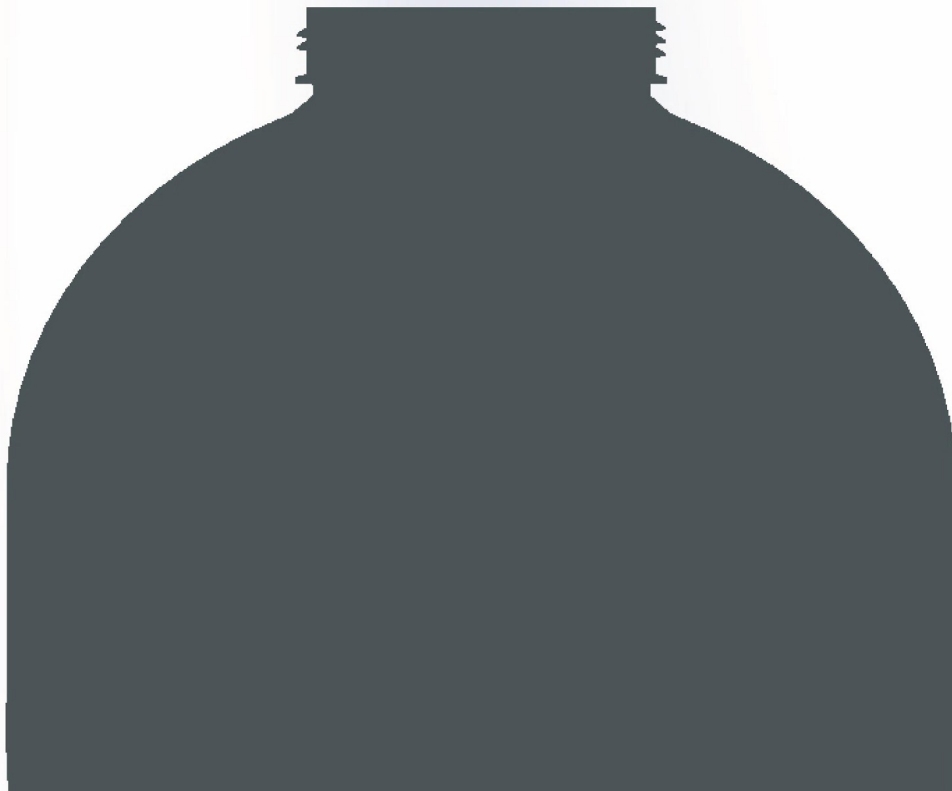
## **FermZilla Design Updated**

All tanks manufactured with a retest date after Dec 2021 had the new taller dome shape as shown below.

Tanks with expiry date after 2021

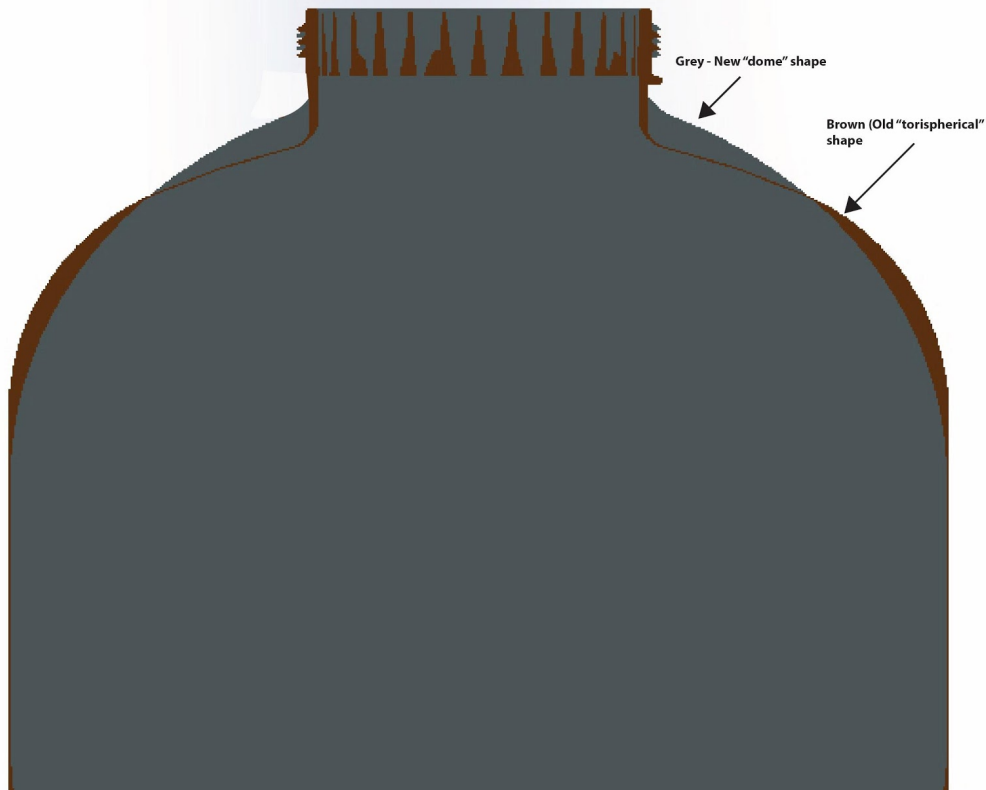
## FermZilla Superimposed

The image below shows the two tank shapes superimposed on top of each other with the brown showing the old tank and the grey shows the new tank design.

Design change made to increase pressure holding capacity and reduce fatigue around neck area.

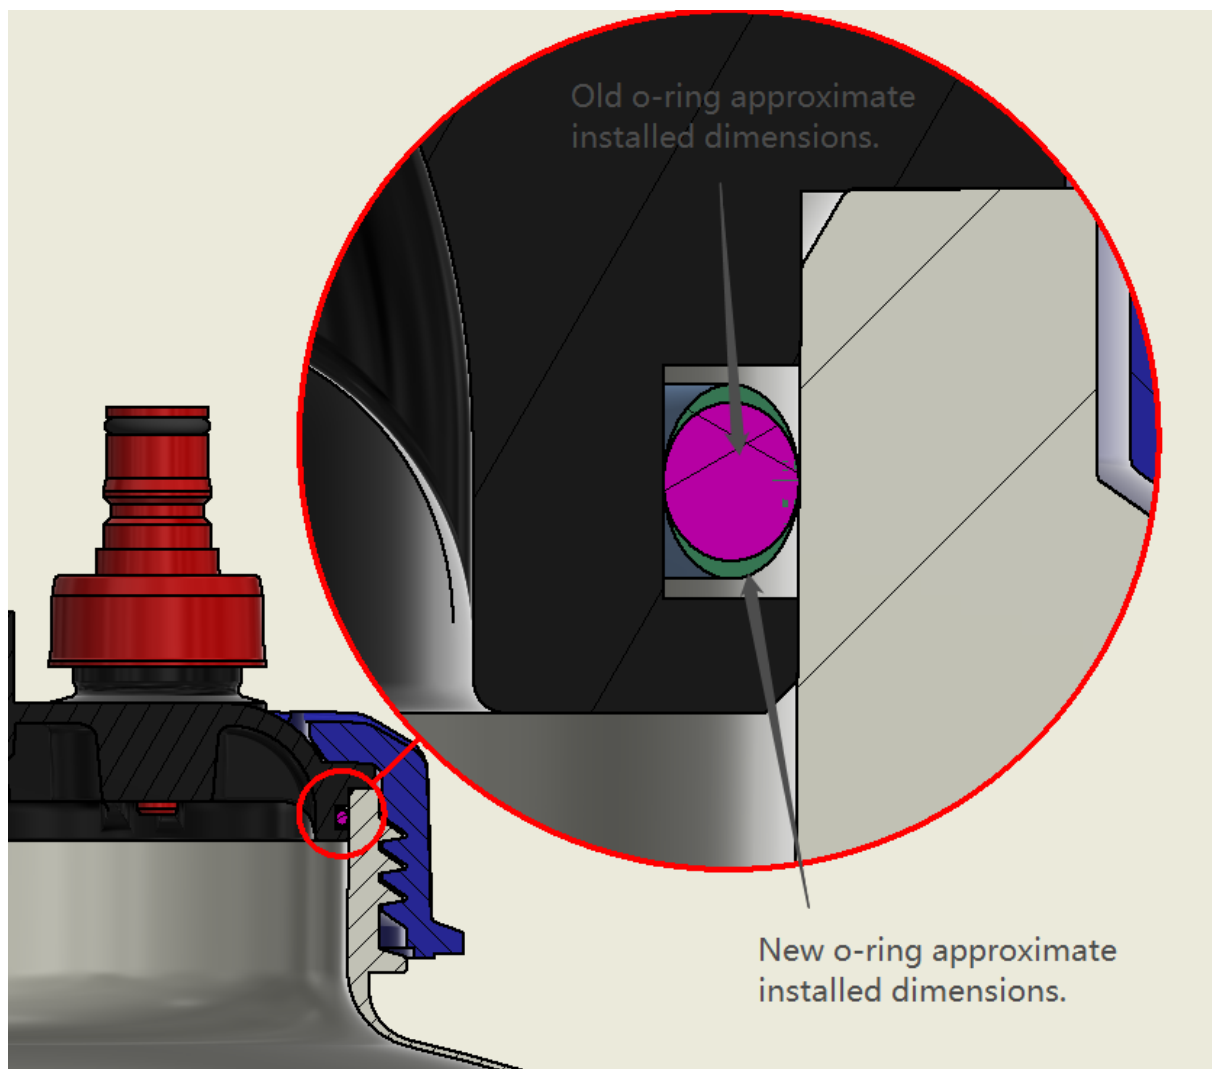
After initial release, feedback was received from a small number of customers with sealing issues concerning the lid of the FermZilla Unitanks. Sealing issues would generally occur after a couple of uses.

The issue was able to be traced back to a combination of o-ring memory and slight out of roundness in the neck of the tanks that is inherent in any PET vessel with a mouth of this size. The decision was made to increase the cross sectional area of the o-ring in the lid of the FermZilla to a size that is slightly larger than what would normally be used in an equivalently radial sealing application in machined components.

The image below shows the approximate difference in installed o-ring dimensions. There is significantly more compression in the new o-ring.

These changes were made soon after release and no negative feedback regarding the lid sealing has been received since.

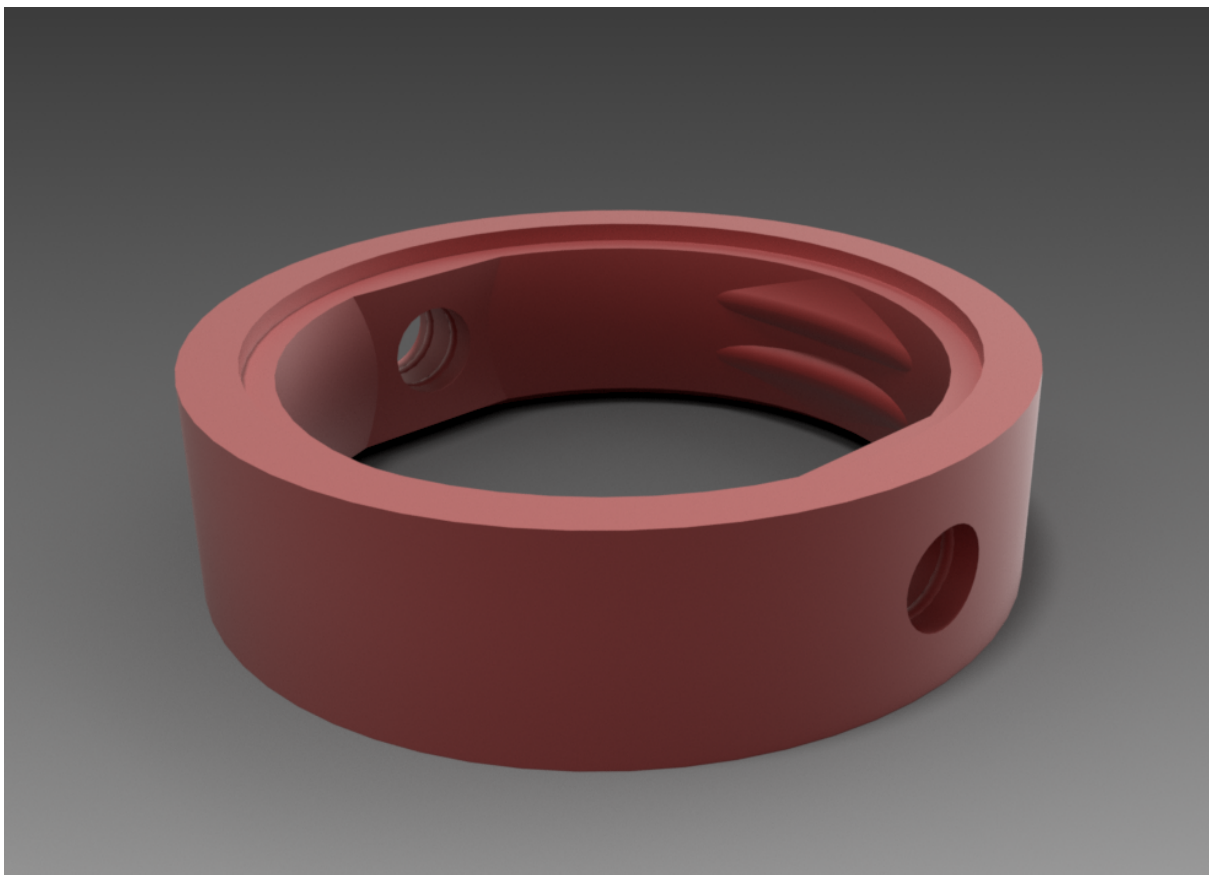
We occasionally received feedback from customers about a very slow drip occurring from the butterfly valve seal. This drip seems only to occur under certain conditions, namely when rapidly cold crashing under pressure. This issue can be traced to a slight mismatch in the coefficient of thermal expansion in the various components of the butterfly valve coupled with the compression set of the seal material. It is not possible to match the coefficients of thermal expansion in these parts, so the decision has been made to switch the seal material to a different elastomer with a lower durometer and better compression set. The butterfly seal in the most recent FermZillas will be made from Silicone. Silicone is a very reliable sealing material and typically has equally good chemical resistance, as the previous EPDM seals, to the beverages and cleaning chemicals that it will see under normal usage conditions. Seals are backwards compatible with previous valves.

Butterfly seal image below.

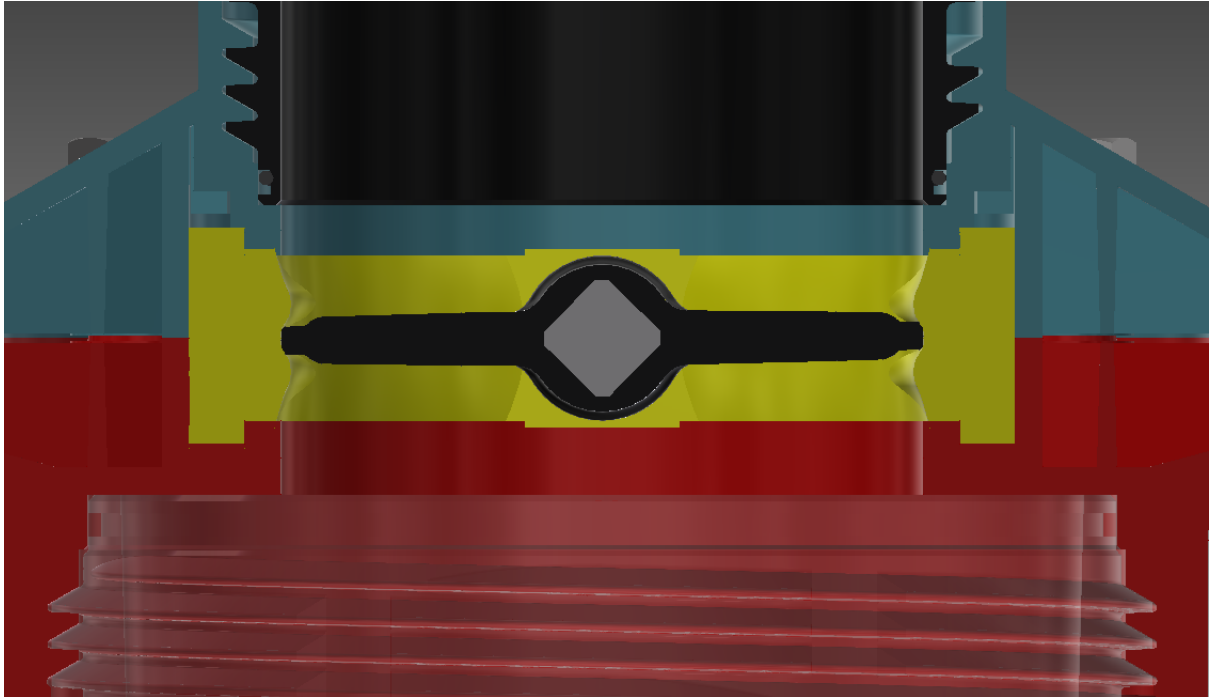
Installed butterfly seal (yellow) in dump valve assembly.

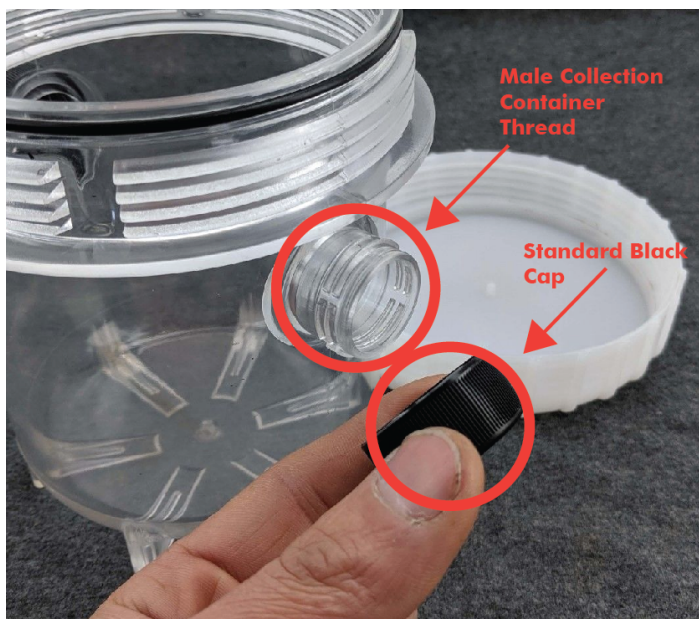
With that said, on a couple of instances customers have forgotten to do this and continued fermentation can cause the build up of pressure causing the collection container to leak or rupture.

The standard assembly includes a male thread on the collection container and a standard black cap as shown in photo below.

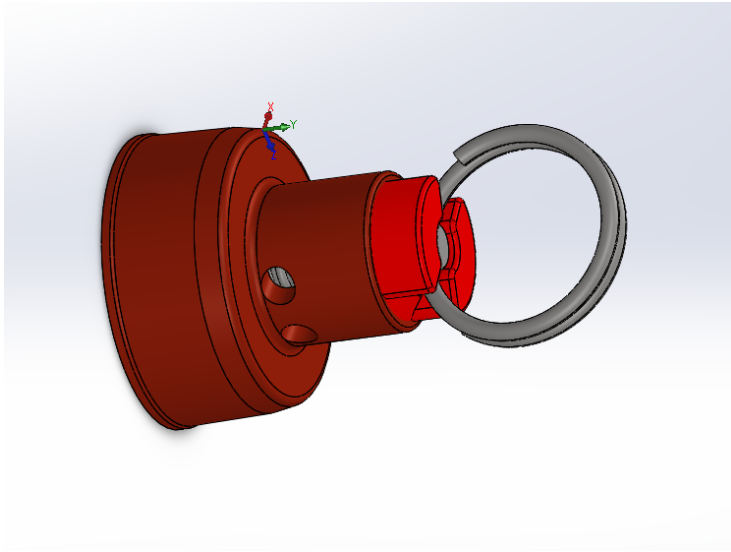
As a result of some customers not following the instructions perfectly at the end of 2020 KegLand will also have a pressure release valve cap that will replace the standard black cap. This part will look like this:

When fitted this cap will give an added level of safety and ensure that even if a customer accidentally closes the dump valve and has continued fermentation in the collection container the chance of damage to the Fermzilla collection vessel will be greatly reduced.
